# PICP Joint Stabilization

## Problems of Un-Stabilized Aggregate Infill

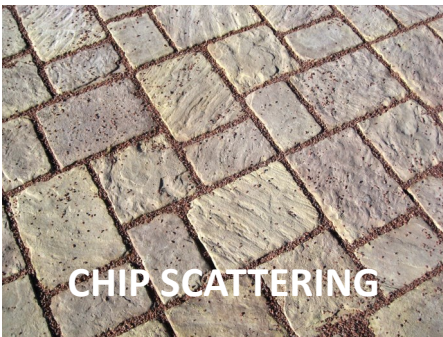
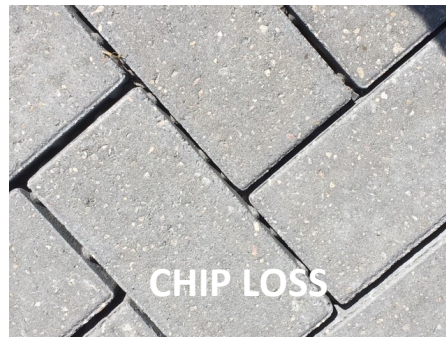
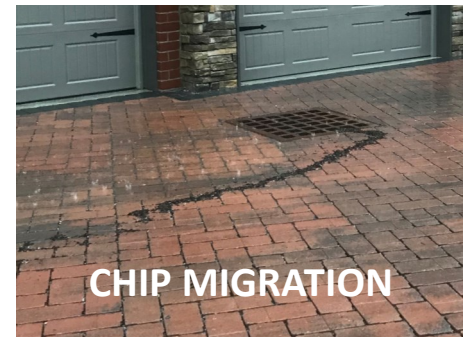
The PICP system is an excellent solution for storm water management but an issue that it faces is the migration of the un-stabilized aggregate infill. When the infill migrates onto the PICP surface it can cause a slip and fall safety hazard, create an unsightly appearance, potentially contaminate the drainage system, and/or no longer be compliant with the ADA. The migration of the infill may be caused from poor quality aggregate infill and/or the lack of stabilization to resist the extractive forces from washout, traffic, and pavement maintenance.

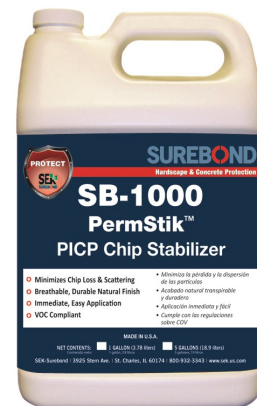
### PermStik™ PICP Chip Stabilizer

- Stabilizes Local #8, #9 Aggregate
- Immediate, Easy Application
- Clear, Water Based Acrylic
- VOC Compliant
- Durable Natural Finish
- Protects Surface Against Water, Salts & Atmospheric Weathering
